## 05/19/2023

## **COMPLIANCE SOLUTIONS**

## Bringing a Bank Roof up to code!

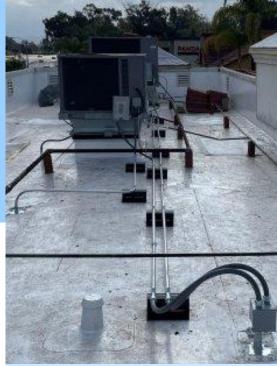
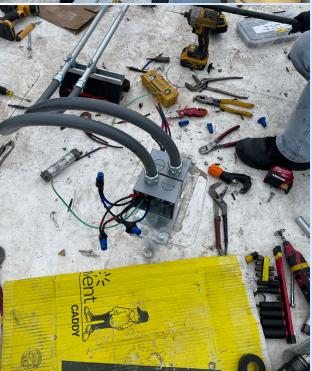
Client had a new roof installed only to note that the previous contractor installed roof conduits using interior couplings that were installed flush with roof line.

We pulled new wire, made rigid support points, foam roof blocks and used all new exterior rain tight connections.
